# Product Support Bulletin 2005-005

## Maintenance of Way ~ Work Equipment Bulletin

**SUBJECT:** Wing Lift Cylinder Pin Replacement Kit – 660057

**MACHINE MODEL(S):** Model M Ballast Regulator

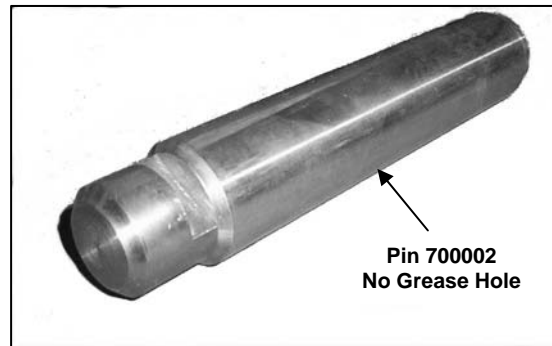
Figure 1

**SUMMARY:** There have been reports of Wing Lift Cylinder Pins breaking during use. The break normally occurs in the area of the pin grease hole. To solve this problem, a new pin has been designed without a grease hole. A grease fitting is added to the Rod-end Clevis of the Wing Lift Cylinder (p/n7500-116) to lubricate the pin.

**ACTION:** The Wing Lift Cylinder Rod End Pin (B-4705-2) should be replaced with the new **Pin (p/n 700002)**. See Figure 1. The new pin is direct replacement for the original pin. However, the cylinder must be drilled to accept a **Grease Fitting (p/n 3801230)**. See Figure 2. The **Pin Field Replacement Kit (p/n 660057)** includes a Pin, Grease Fitting and clevis drilling instructions. Two kits are required per machine. The kit may be installed in about an hour.
