Product Support Bulletin 2018-002

Maintenance of Way ~ Work Equipment Bulletin

SUBJECT: HD TRIPP OVERHEAD CONSOLE GROUND

MACHINE MODEL(S): TRIPP HD

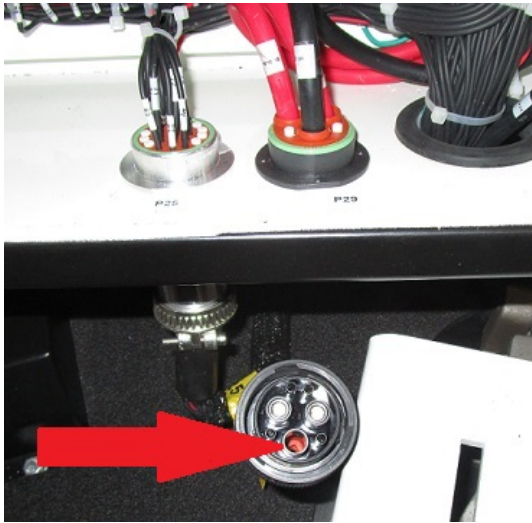
P29-6 CONNECTOR

SUMMARY: The harness that provides the overhead console with power and ground from the center console is missing the ground (#2 wire).

ACTION: A #4 AWG ground cable (P/N 87120146) with a crimped female socket on one end and ring lug on the other will need to be installed in the cab. First the raceway covers located below, along, and above the right door will need to be removed. Then the P29 connector located below the center console will need to be disconnected and have a crimped female socket of the cable inserted into the #6 position. Next run the cable through the raceways and into the overhead console with the ring lug being secured to the Ground stud in the overhead console. After installing the cable reconnect the P-29 connector and reinstalled the raceway covers. Allow 1 hours for installation. See page 2 for images
