Product Support Bulletin 2010-020

Maintenance of Way ~ Work Equipment Bulletin

SUBJECT: Frame Tie-Down Reinforcing Kit – 98510092

MODEL(S): NETP – Nordco Epoxy Tie Plugger

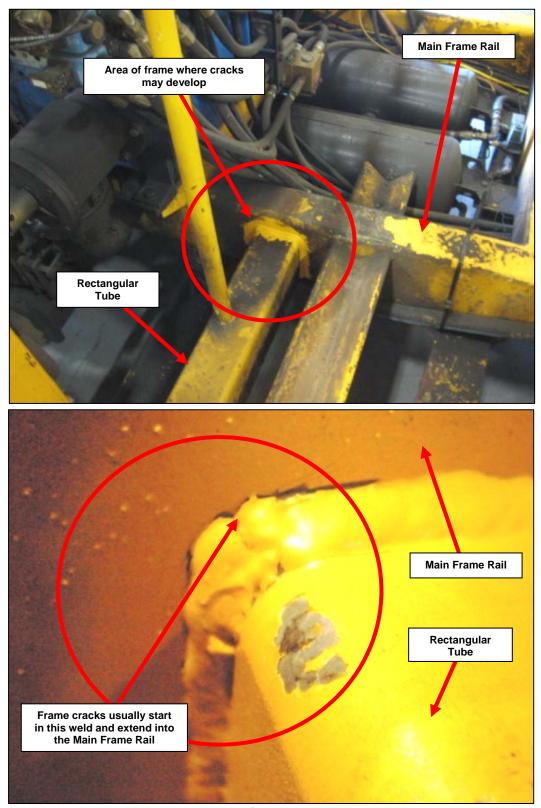
SUMMARY: There have been reports of cracks developing in the frames of some of these machines. The cracks occur at the junction of the Main Fame Rails and the Rectangular Tubes just in front of the chemical tanks. See Figure 1 on Page 2. These cracks can be caused by excessive force applied to the frame tie-down points. The 98510092 Frame Tie-Down Reinforcing Kit is available to reinforce the frame in the affected area.

Figure 1 Typical frame crack (LH side shown)

- **IMPACT:** Frame cracks could lead to weakening of the frame if not repaired.
- ACTION: The 98510092 Frame Tie-Down Reinforcing Kit includes all parts required to properly repair and reinforce the area of the frame subject to cracking. Complete welding instructions are also included. See Figures 2, 3 and 4 on Page 3 and Figure 5 on Page 4. Follow all recommended Lock Out/Tag Out procedures before attempting to repair the frame. Both chemical tanks **MUST** be removed before repairing the frame.
- WARRANTY: Kit 98510092 will be supplied under warranty for machines with s/n 510001-510035 until June 30, 2011. Please contact the Nordco Service Department at 800-445-9258 to order the 98510092 Frame Tie-Down Reinforcing Kit. One kit is required per machine.
