Product Support Bulletin 2022-004

Maintenance of Way ~ Work Equipment Bulletin

SUBJECT: TRIPP HD Main Frame Reinforcement

MACHINE MODEL(S): TRIPP HD & T4 HD and TPX

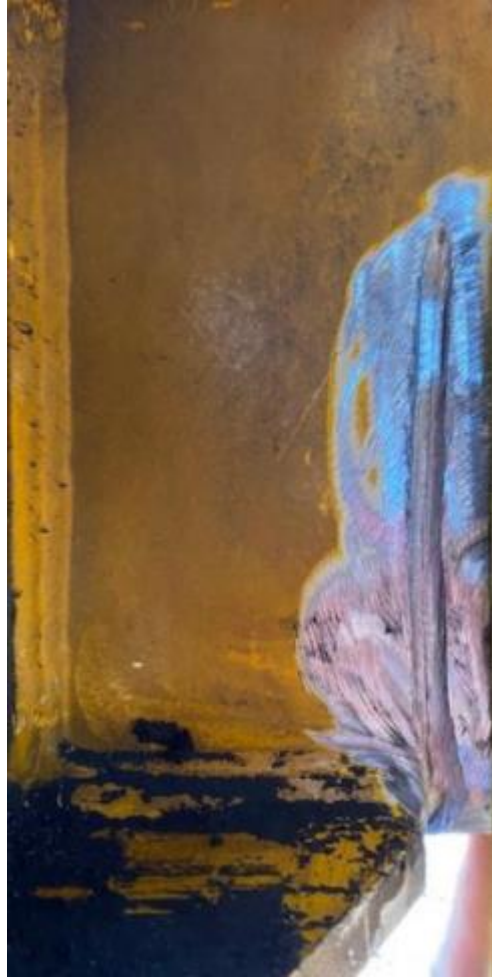
Figure 1

SUMMARY: It has been discovered on a few of the TRIPP HD & TPX frames that some cracking has appeared on the main tube of either the LH side or RH side or both sides. This can be found where the upper and lower gussets (on the rear edge) connect the crossmembers to the main frame tubes at the rear of the machine. The cracking can be found in the area below the hydraulic tank and cab area. See Figure 1. This picture is showing where a crack developed and was gouged out to highlight the affected area more clearly.

ACTION: To start with, the area where the upper and lower gussets end on the main tube will need to be inspected thoroughly. This may require removing any grease or dirt deposits around it. Note: If any cracking is found upon inspection, it will need to be repaired first. This Bulletin includes a set of instructions on how to first repair the cracks and then how to install additional extension gussets in the affected area. Note: The installation of the gussets is required even if no cracking is found in the main tube.

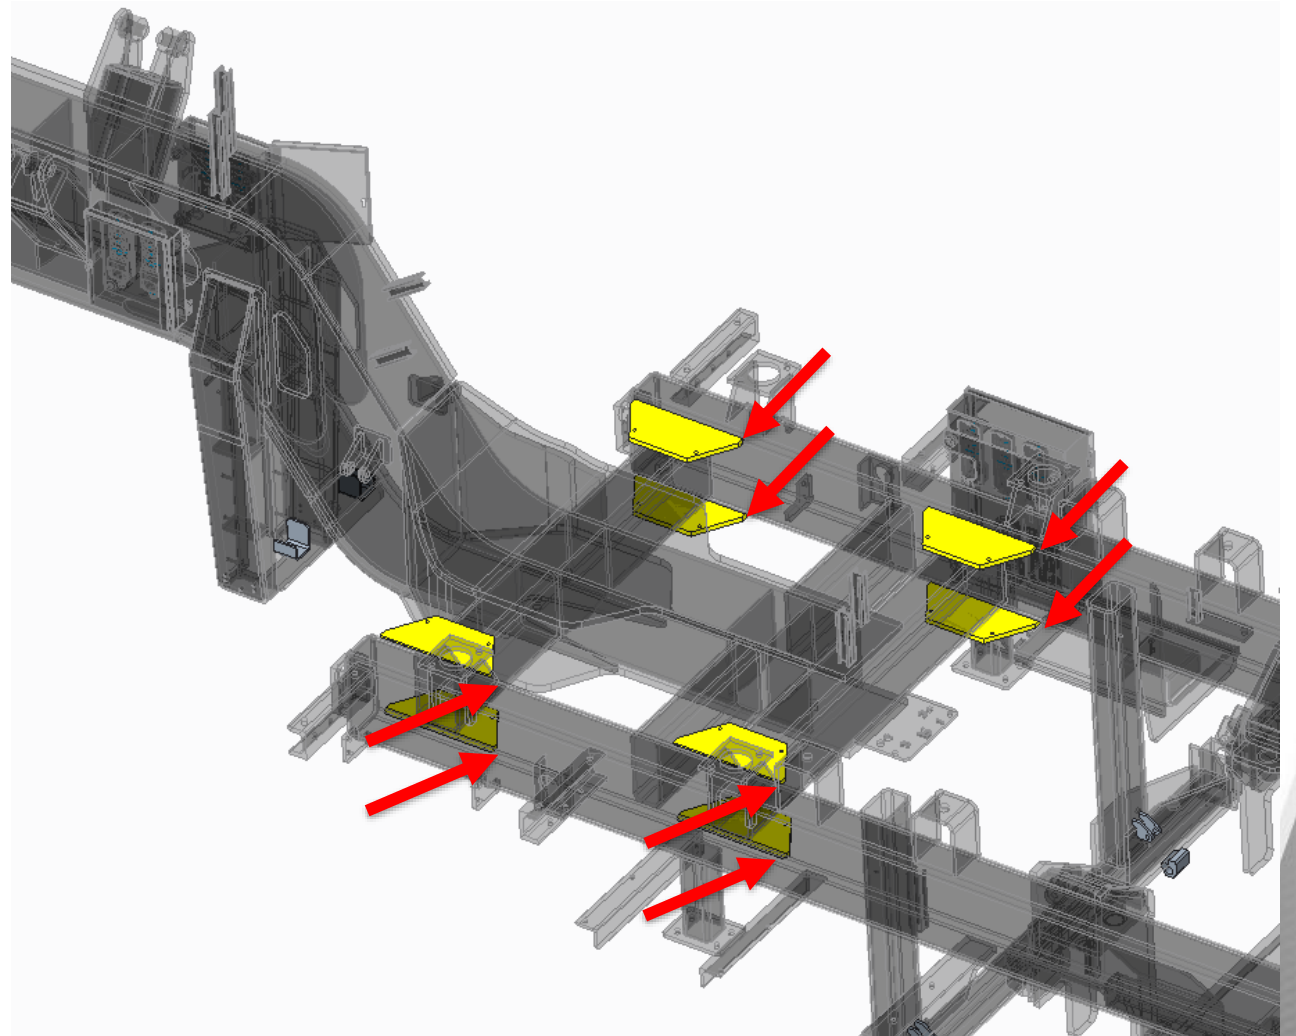
CRACK REPAIR IN EXISTING FRAME TUBE

- Crack prep
 - To aid in finding the end of the crack first remove paint and use mag particle or dye penetrant testing
 - Assuming crack is through the entire wall, grind close to the inner wall. Wall thickness is 1/2", a grind depth of 3/8" to 7/16" is optimal
 - Grind 1/4" past the end of the crack as determined from the testing
 - Do not grind a large gap as it will need to be filled back up
- Taper side walls as needed to ensure a good weld
- Recommended to use 6010 stick electrodes for the root weld
- Remaining filler weld can be done with wire (MIG) **min 70 ksi**
- After weld is complete, grind weld so it is flush with the outside of the tube
- After grind, polish area with flapper wheel

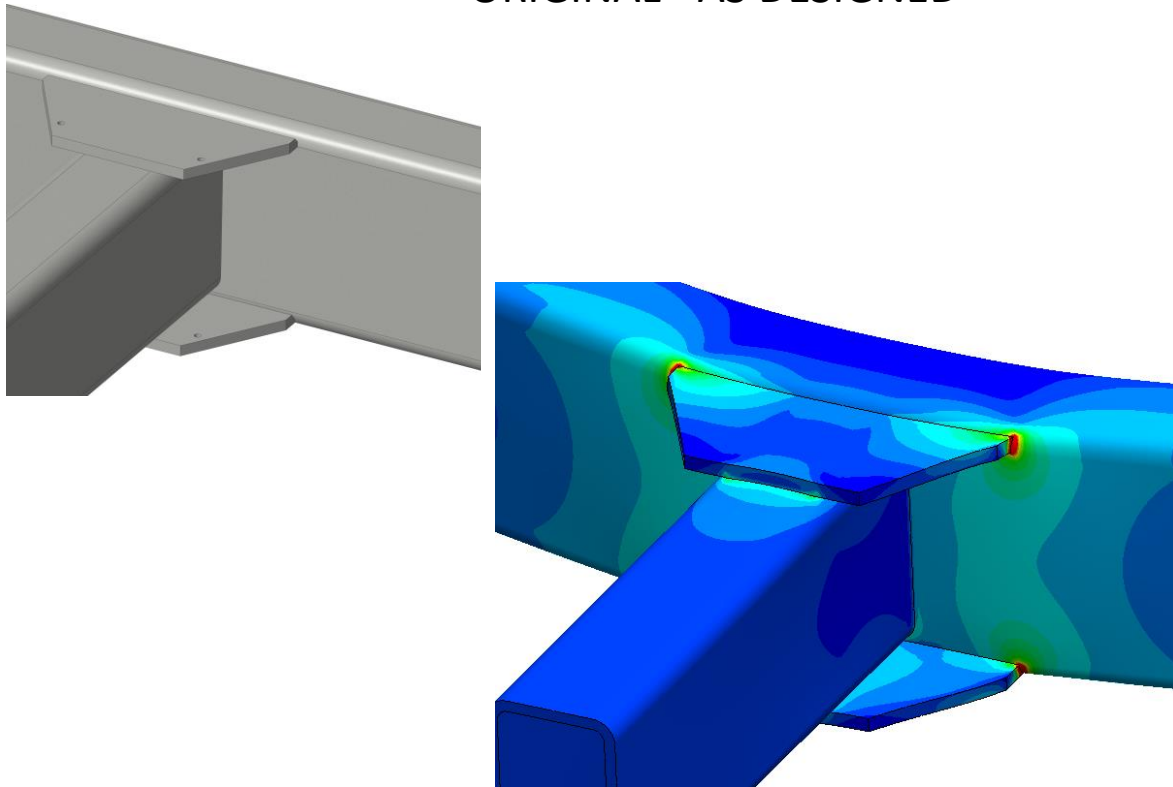
ORIGINAL - AS DESIGNED

- Adding a plate, while easier, does not resolve the stress concentration issue
- Fatigue life gains, crack initiation, are expected to be minimal even with a 3/8" or thicker plate added in this area.

NOTE: If a plate has already been added and fully welded in from a prior field fix it is encouraged to add the gussets with the outlined process while modifying the gusset geometry optimize fitment.
