Product Support Bulletin 2022-004

Maintenance of Way ~ Work Equipment Bulletin

SUBJECT: TRIPP HD Main Frame Reinforcement

MACHINE MODEL(S): TRIPP HD & T4 HD and TPX

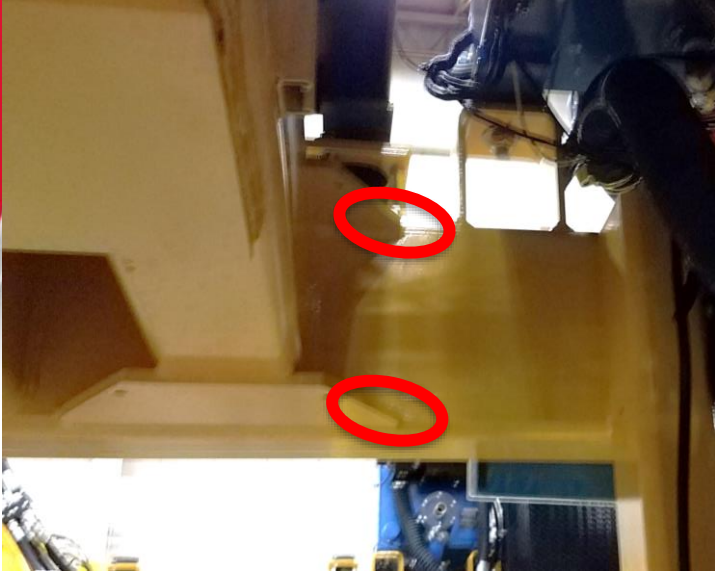
BEFORE

SUMMARY: It has been discovered on a few of the TRIPP HD & TPX frames that some cracking has appeared on the main tube of either the LH side or RH side or both sides. This can be found where the upper and lower gussets (on the rear edge) connect the crossmembers to the main frame tubes at the rear of the machine. The cracking can be found in the area below the hydraulic tank and cab area. See Figure 1. This picture is showing where a crack developed and was gouged out to highlight the affected area more clearly.

Objective: Weld support gussets to rear side of trapezoid plates (8 total).

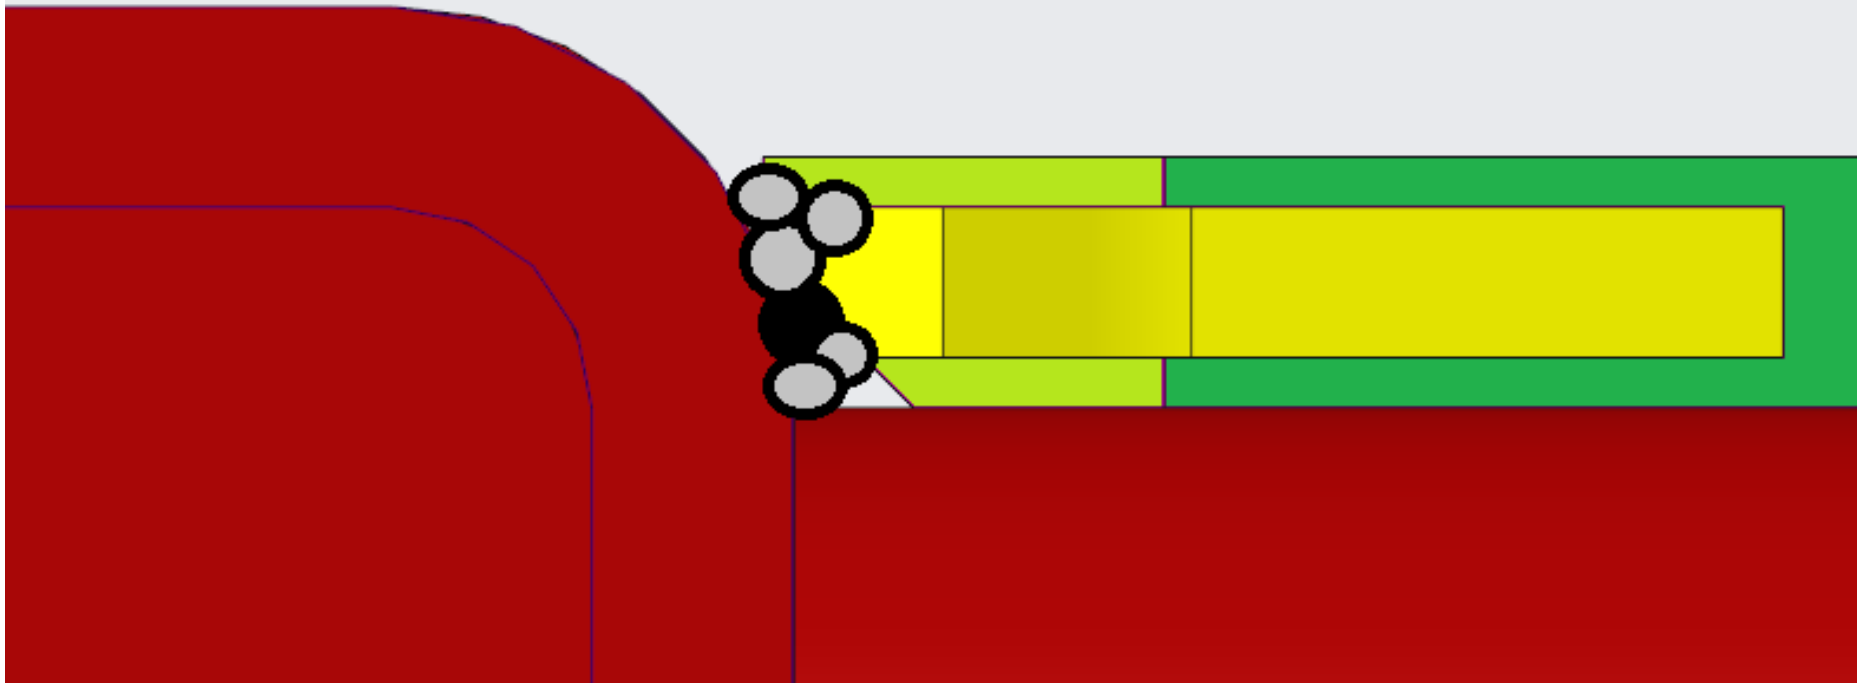
REFERENCE INFORMATION - DOUBLER PLATE

- Adding a plate, while easier, does not resolve the stress concentration issue
- Fatigue life gains, crack initiation, are expected to be minimal even with a 3/8" or thicker plate added in this area.
